Preparation design and considerations for direct posterior composite inlay/onlay restoration

Jason Fligor¹

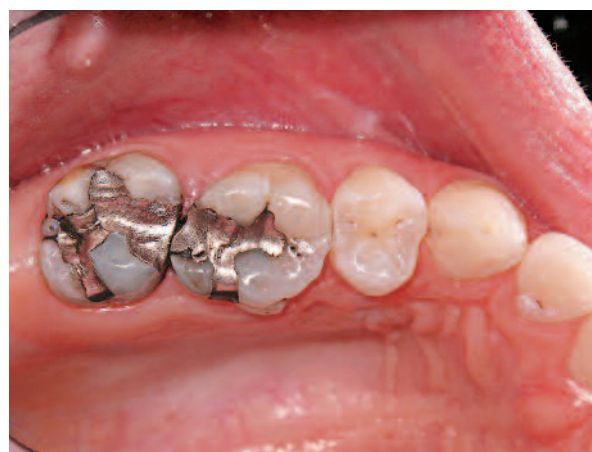
Figure 1: Preoperative occlusal view demonstrated the presence of failing amalgam restorations in the posterior region, as well as recurrent decay and multiple fracture lines with staining.

A 33-year-old female patient presented for routine dental care. Failing amalgam restorations were evident on teeth #14(26) and #15(27), and recurrent decay with multiple stained fracture lines were noted (Figure 1). Radiographic evaluation revealed deep existing restorations with no periapical abscesses or other significant findings (Figure 2). The patient was asymptomatic in both teeth, and porcelain restorations were planned. Although the clinician anticipated the need to place inlay or onlay restorations, the amount of recurrent decay and the location of fractures would necessitate prophylactic removal of a weakened or undermined cusp.¹⁵

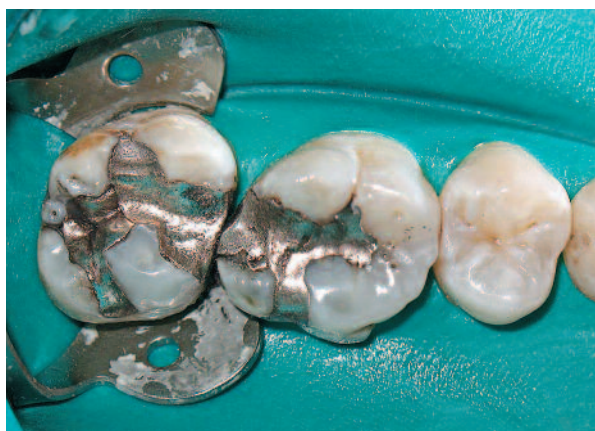
Figure 3: Rubber dam isolation was achieved after preoperative occlusal analyses were performed.

The first step in restoring teeth #14 and #15 was to mark the patient's bite with articulating paper (ie, Accu-film 2, Brazos Valley Dental Supply, Hewitt, TX; Bausch Articulating Silk, Pulpdent Corp, Watertown, MA). Major centric stops and functional movements were noted, and the marks were left on the teeth. Rubber dam placement was facilitated following anesthesia delivery (Figure 3). Using a CAD/CAM system (eg, Cerec, Sirona, Charlotte, NC; e4D, D4D Technologies, Richardson, TX; Lava, 3M ESPE, St. Paul, MN), preoperative images were then

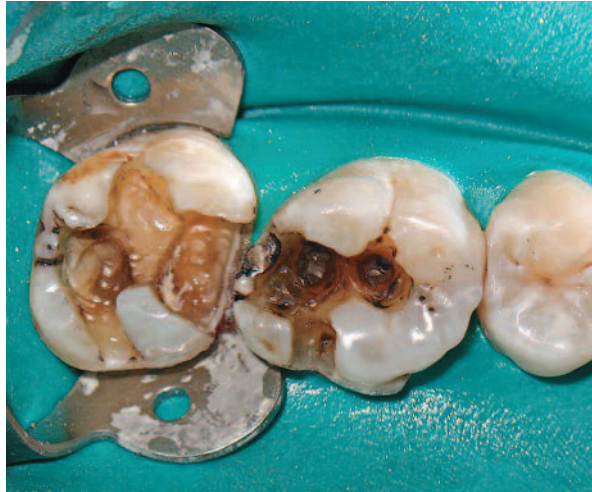
Figure 4: Occlusal appearance immediately following removal of the preexisting amalgam restorations.

Preparation began with the removal of the previous alloy using a carbide bur (eg, H21E, Brasseler USA, Savannah, GA; 557, Dentsply Midwest, York, PA). Following alloy removal, the teeth were evaluated for recurrent decay, fractures, and undermined cusps (Figures 4 and 5). Diamond burs (eg, C1P2, Brasseler, USA, Savannah, GA; C274-016, Axis Dental, Coppell, TX) of varying shapes and sizes were then used to further remove decay and refine the preparations (Figure 6). Once all the decay and fractures were removed, the remaining cusps and tooth structure were examined for potential areas of weakness. Positioning of the cavosurface margins was based on the patient's preoperative occlusal patterns to ensure proper bite maintenance.

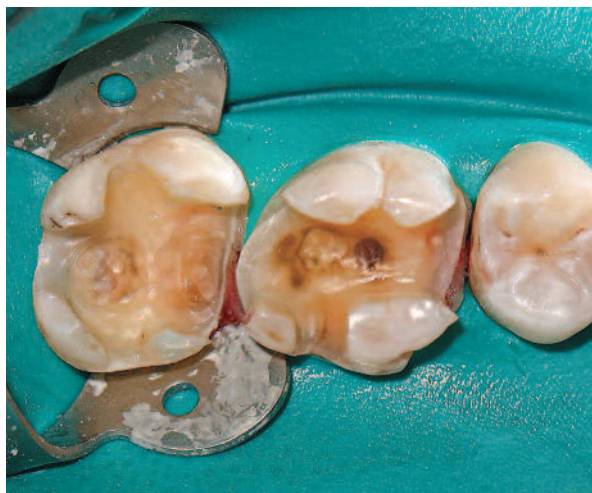
Figure 5: The preparation design was further refined to ensure complete removal of decay, fractures, and undermined cusps.

The mesiolingual cusp of tooth #15 was severely undermined and had a horizontal fracture line running beneath it. Bonding to this cusp would not provide for a strong, long-term, restoration.¹⁶ The cusp was, therefore, removed, and a broad, flat, butt joint was placed for the porcelain margin. Because the distolingual cusp of tooth #14 remained and could create a challenging spot for a ceramist to press porcelain as well as a difficult spot for the CAD/CAM machine to mill. Either fabrication technique would leave a small finger of porcelain on the lingual that would be very susceptible to fracture either on handling or seating. This cusp was also removed, and a butt margin was prepared.

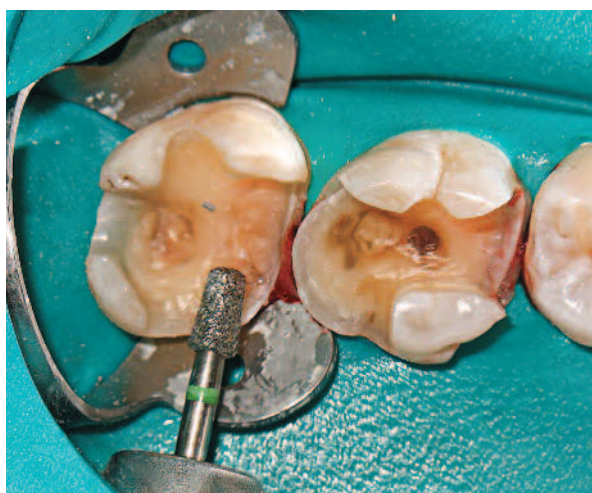
Figure 6: A round-end diamond bur was used to smooth the occlusal anatomy of the preparation.

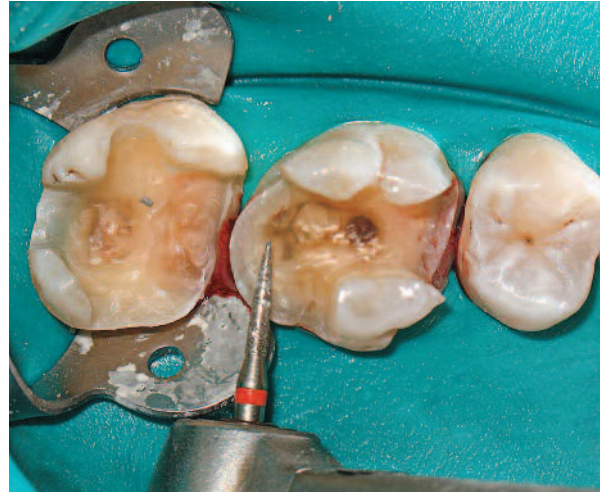
Figure 7: A flame shaped bur was used to create proper marginal anatomy on the pulpal and gingival floors.

The preparations were then further refined. Any sharp internal line angles were removed, the pulpal and gingival floors were smoothed, and the buccolingual walls of the proximal boxes were finished with a fine flame-shaped diamond (ie, Axis Dental, Coppell, TX) (Figures 7 and 8). Adequate clearances were created for easy seating and finishing of the margins, and hemostasis was achieved (Figure 9). The preparations were then scanned using the CAD/CAM system, and the restorations were milled using an A2 shade block (eg, IPS.CAD, Ivoclar Vivadent, Amherst, NY; Wide YZ Cube, Vident, Brea CA; Paradigm, MZ100, 3M ESPE, St. Paul, MN).

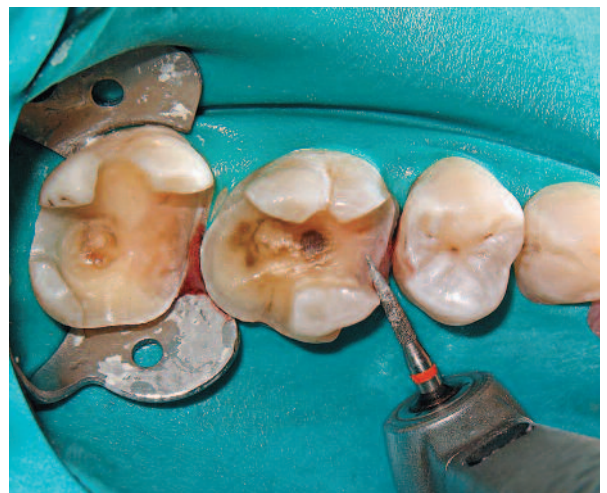
Figure 8: The buccolingual walls of the proximal boxes were then finished to ensure proper retention and seating.

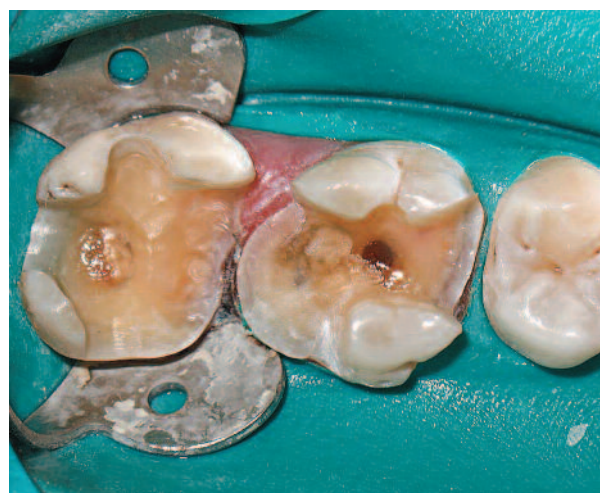
Figure 9: Following refinement of the dentinal walls, adequate clearances were formed and the margins were finished.

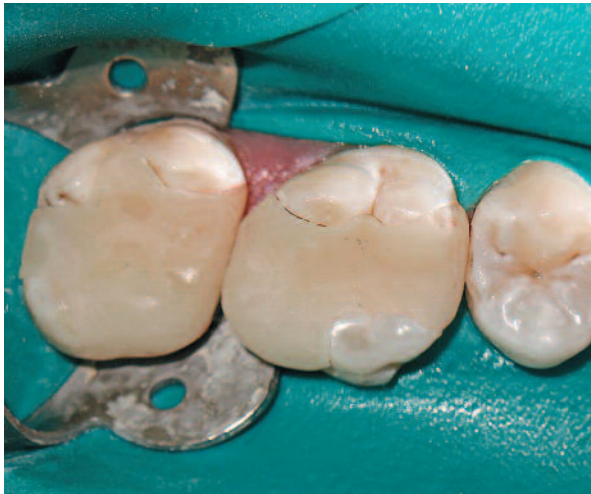
Figure 10: The restorations were tried in to verify correct fit and position prior to cementation.

Both restorations were milled and tried in together (Figure 10). It should be noted that the CAD/CAM system was operated in "correlation mode," which copied the

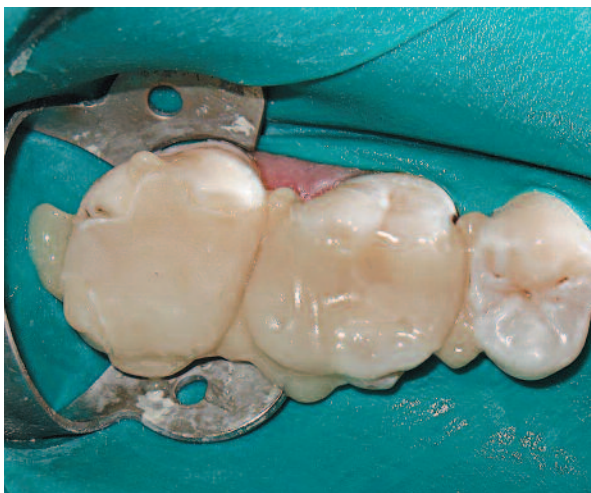
Figure 11: The restorations were simultaneously seated following application of a dual-cured cement material.

patient's existing bite. As a result, there was no need to create any additional occlusal anatomy. Adjustments were made to the interproximal contacts where needed. Once the fit was deemed satisfactory, the restorations were prepared for cementation based on the manufacturer's instructions. The teeth were prepared for bonding using a total-etch technique.¹⁷ A dual-cure cement (eg, Variolink II, Ivoclar Vivadent, Amherst, NY; Calibra, Dentsply International, York, PA; RelyX, 3M ESPE, St. Paul, MN) was placed in the preparations, and both restorations were seated simultaneously. The clinician evaluated the restorations to ensure cement was expelled out from all margins, to ensure they were seated completely (Figure 11).¹⁸

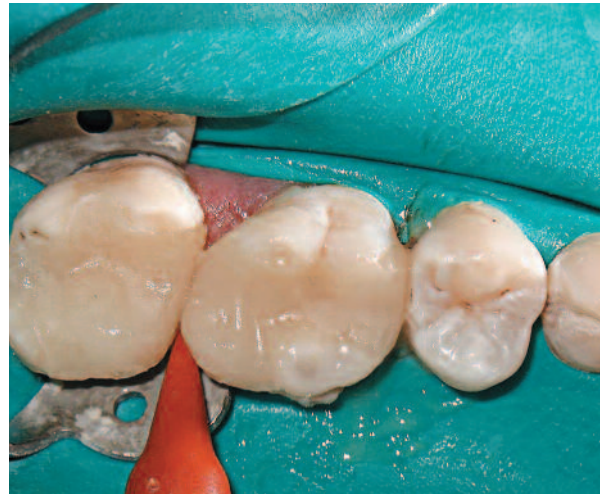
Figure 13: A rubber tip stimulator (ie, Butler Gum, Sunstar Americas, Chicago, IL) was employed to remove residual interproximal cement.

Gross cement removal was accomplished using multiple applicators (eg, Benda Brushes, Centrix, Shelton, CT; Rubber tip stimulator, Butler/Sunstar Americas, Chicago, IL) (Figures 12 and 13). These tools effectively cleaned away cement without causing tissue trauma or bleeding. The restorations were spot-tack cured into place and excess cement was removed from the interproximal regions using dental floss. Once all excess cement was removed, the restorations were cured for a total of 30 seconds (ie, 10 seconds for the occlusal, buccal, and lingual aspects, respectively) (Figure 14).

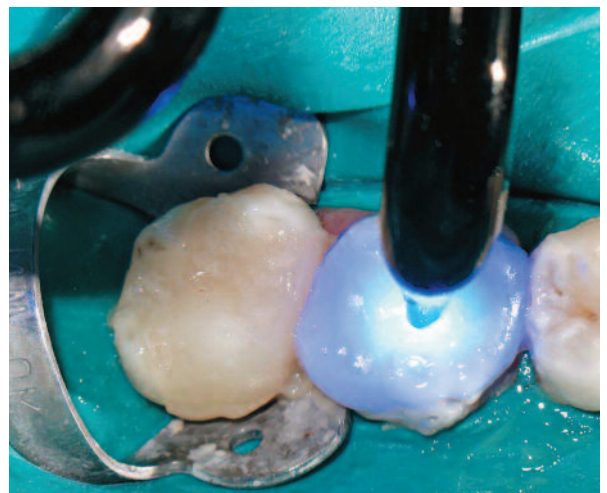
Figure 14: The restorations were tack cured into place to allow final finishing and polishing without jeopardizing the final seat. --

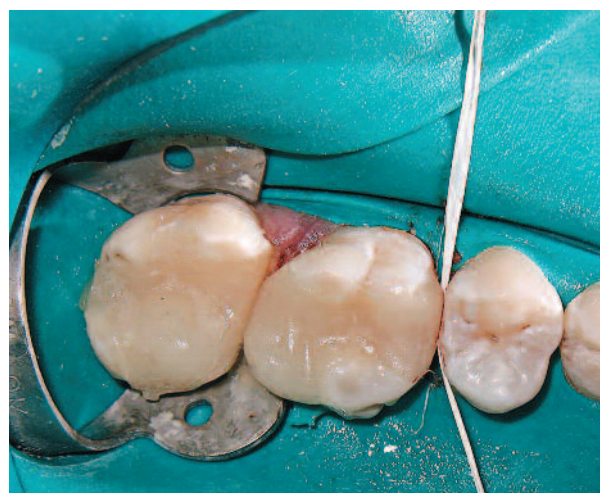
Figure 15: Interproximal cement removal was then finalized using interdental floss to ensure a smooth finish and functional contacts.

Following the final cure, the margins were finished with fine flame- and football-shaped burs. The interproximal areas were flossed a final time and polished with fine, diamond, sanding strips (Figure 15). Clinical and radiographic evaluation took place to ensure a seamless bond and complete seating (Figures 16 and 17). The rubber dam was removed and the patient's occlusion was adjusted. A three-step polishing system (eg, Cera-glaze, Axis Dental, Coppell, TX; Enhance Pogo, Dentsply Caulk, Milford, DE) was used to apply the final polish to the restorations (Figure 18).

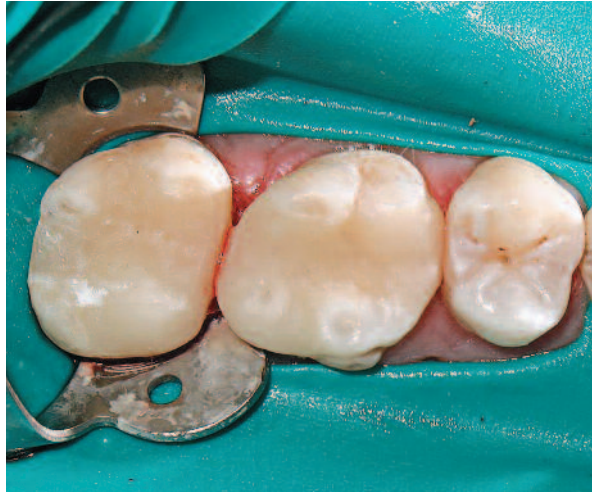
Figure 16: The restorations were subsequently cured on the occlusal, buccal, and lingual aspects. Development of additional occlusal anatomy was not necessary prior to polishing.

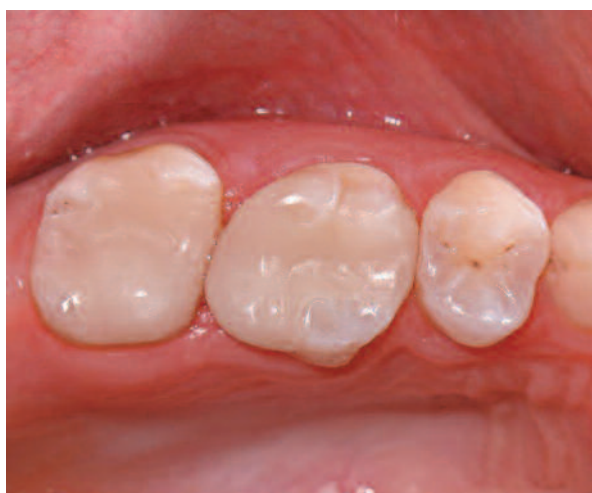
Figure 18: Postoperative appearance of the polished restorations demonstrates enhanced aesthetics and optimal integration with the surrounding tissues.
